**CONNECTICUT RIVER BASIN  
MIDDLEFIELD, CONNECTICUT**

**BESECK LAKE DAM**

**CT 00381**

**PHASE I INSPECTION REPORT  
NATIONAL DAM INSPECTION PROGRAM**

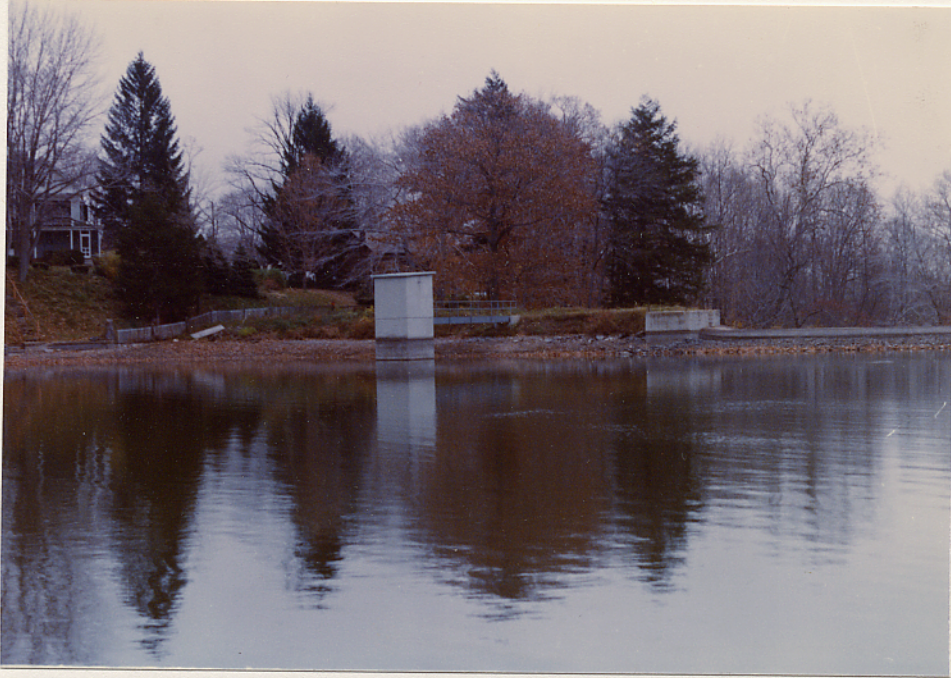
1. Left abutment area and gatehouse

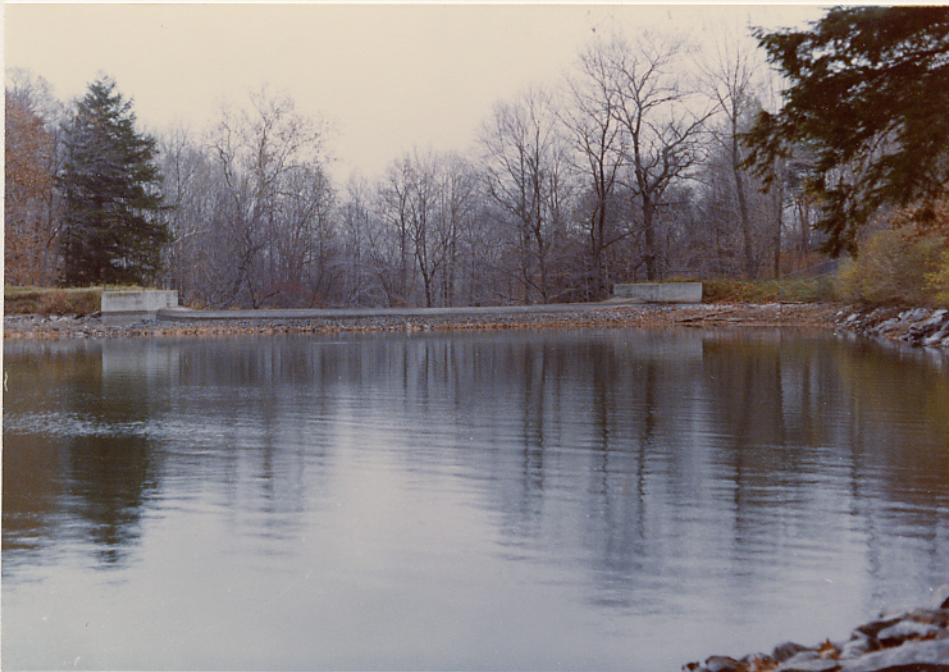
2. Spillway and right abutment

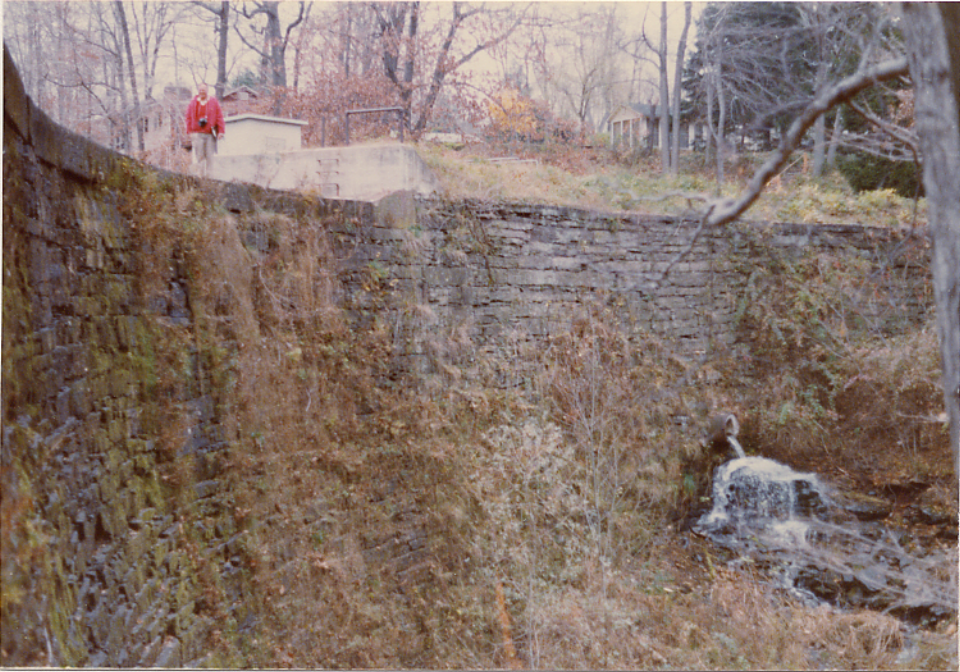
The embankment crest left of the control structure is badly overgrown, and the State's representative for Region 3 advised that the control of vegetation is increasingly difficult since the ban on herbicides. The downstream stone facing is also becoming covered with light growth, nourished by moisture passing through the dam (Appendix C, Photo No. 3)

3. Downstream face, spillway and left abutment

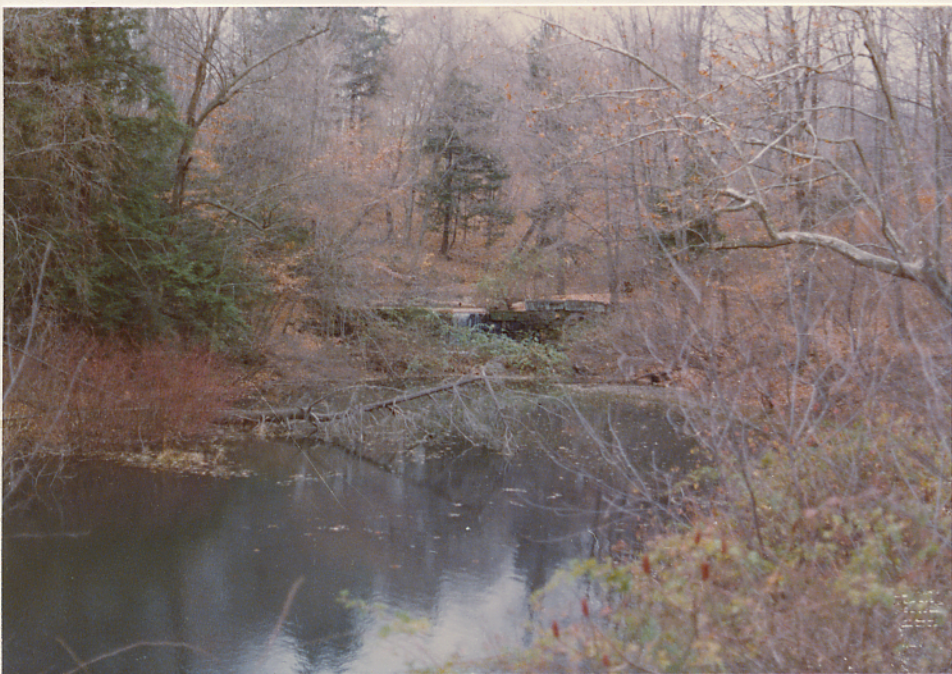
4. Pond and small dam on Ellen Doyle Brook, from Rte. 147 bridge

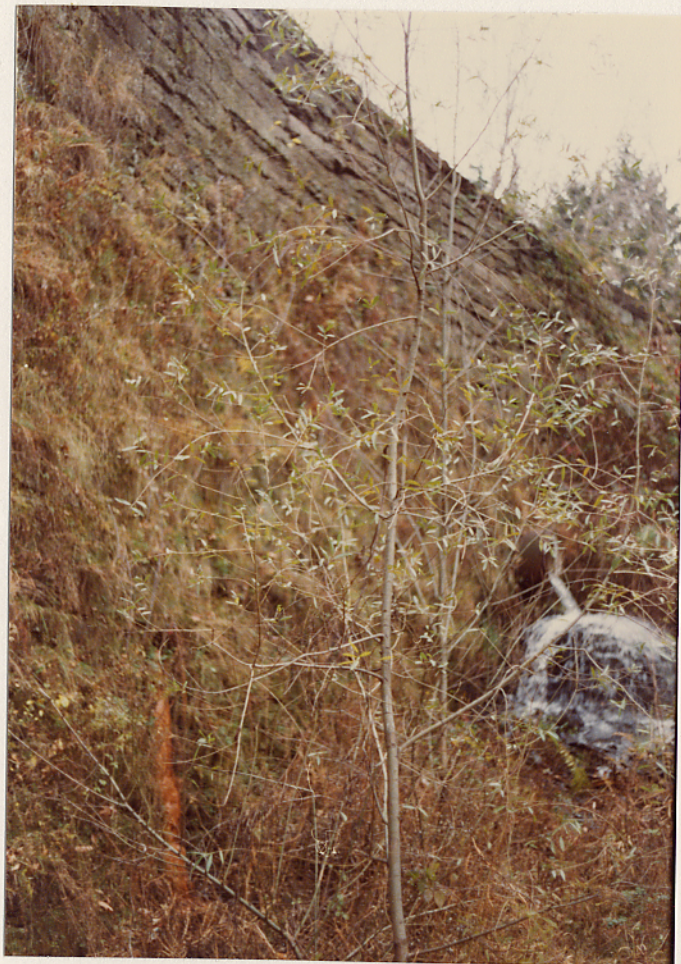
An abandoned outlet pipe through the dam also leaks persistently, as shown by the characteristic deposit of rust-colored mold (Appendix C, Photo No. 5).

A 12 in. dia. pipe outlet emerges at the face of the dam to the right of and at about the same level as the 20 in. dia. outlet pipe. This outlet has been abandoned, but a rusty leakage was seeping from the pipe. A 1971 memo suggested that the pipe be filled with concrete. It is not known whether this recommendation was carried out.

5. Growth on downstream face. 20 in. dia. outlet (right) and 12 in. dia. abandoned outlet (left).

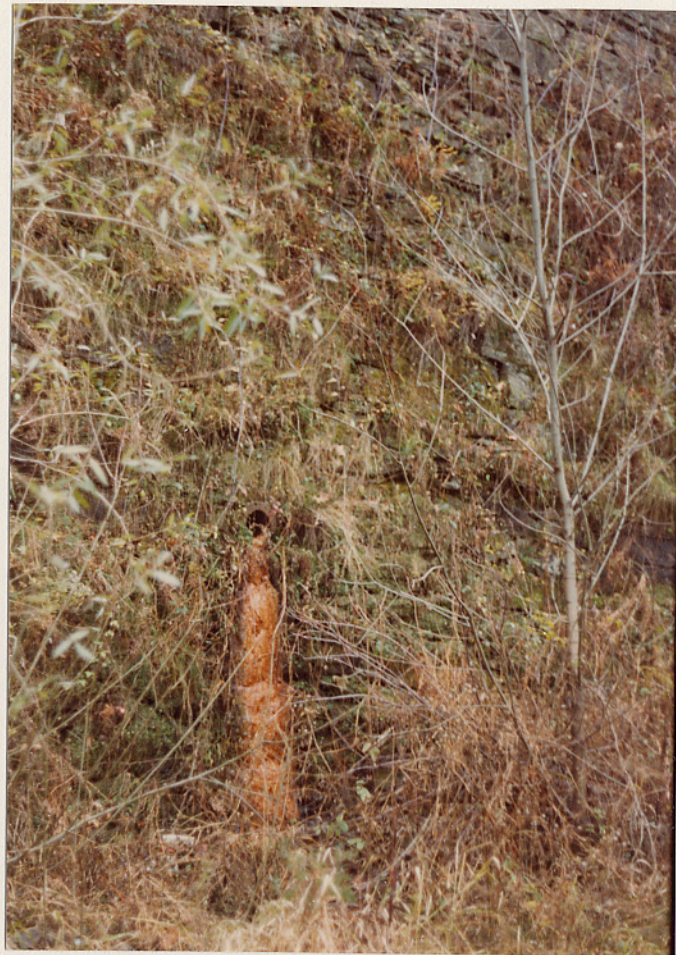
6. Downstream face and 12 in. dia. abandoned outlet.
